Subject: Visual Phase 1 Milestone Inspection (553.889)  
Indigo Pines Condominium Association  
99 Bent Tree Drive,  
Daytona Beach, FL 32114

Elite Engineering has conducted a Phase 1 Milestone Inspection of ten (10) multi-story wood framed structure(s) located at the subject address.

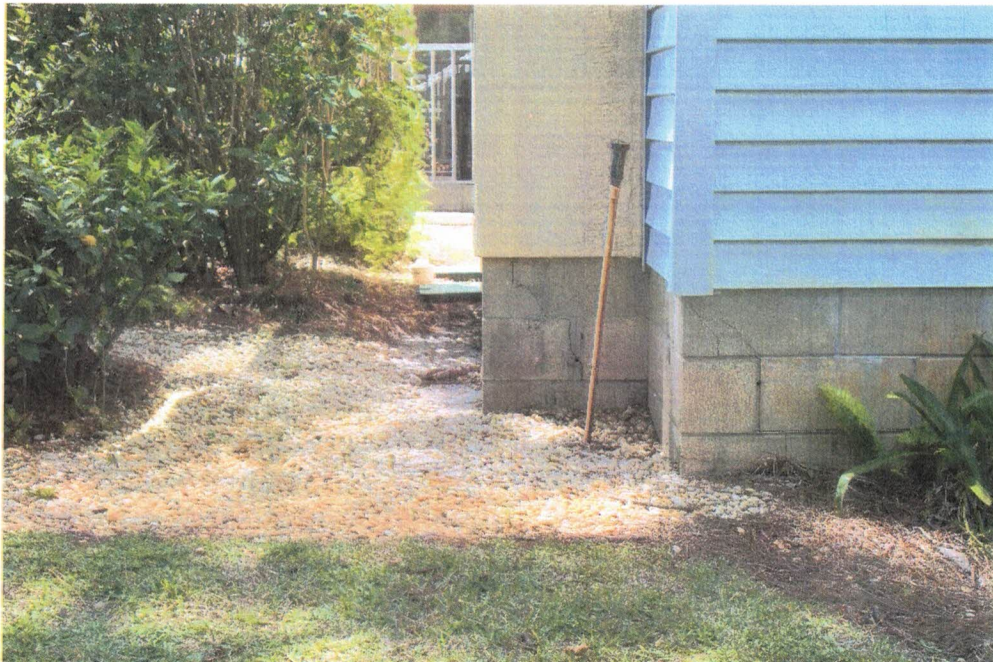
***MINOR STEMWALL FOUNDATION CRACKS – CONDO TO MONITOR FOR PROGRESSION - MAINTENANCE  
ISSUE***

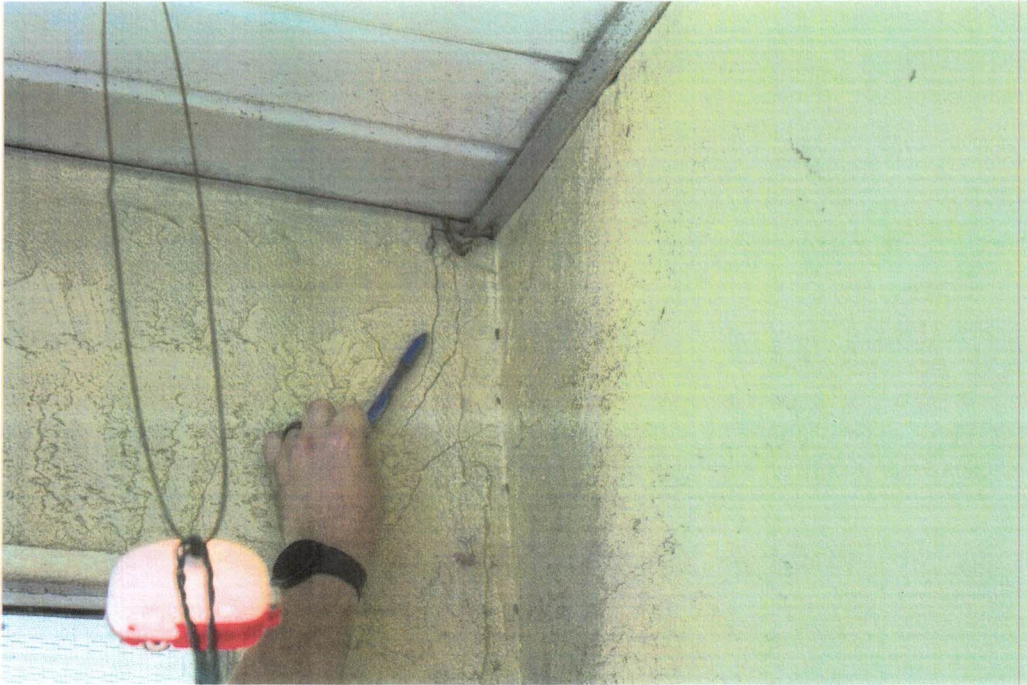
***TYPICAL STUCCO CRACKS – CONDO TO MONITOR FOR PROGRESSION - MAINTENANCE ISSUE***

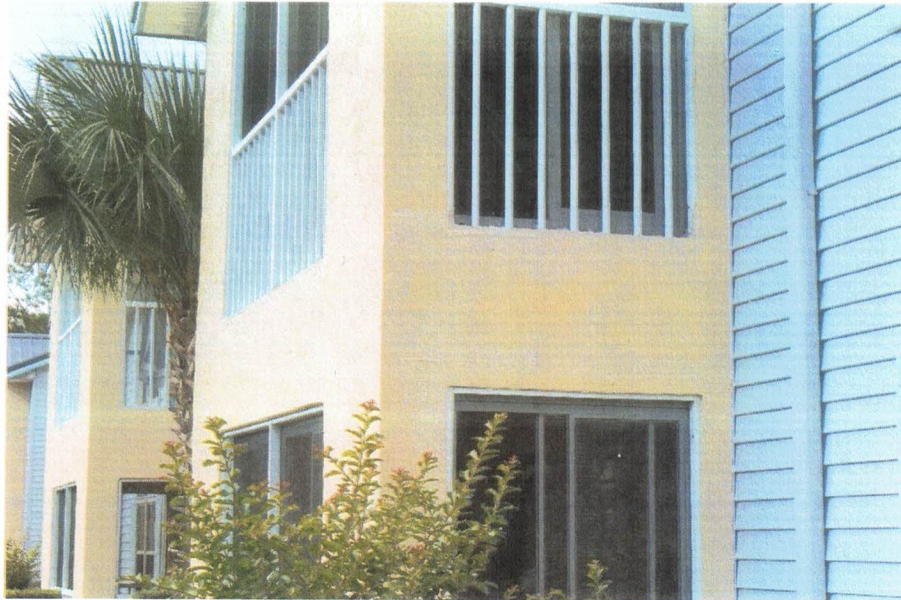
***TYPICAL EVIDENCE OF FRAMING/STUCCO REPAIRS AT EXTERIOR OPEN PORCHES. THIS IS A KNOWN ISSUE TO THE CONDO AND SHOULD BE CONTINUALLY MONITORED AS WATER THAT ENTERS OPEN PORCH DOES NOT HAVE A GOOD EXIT PATH.***

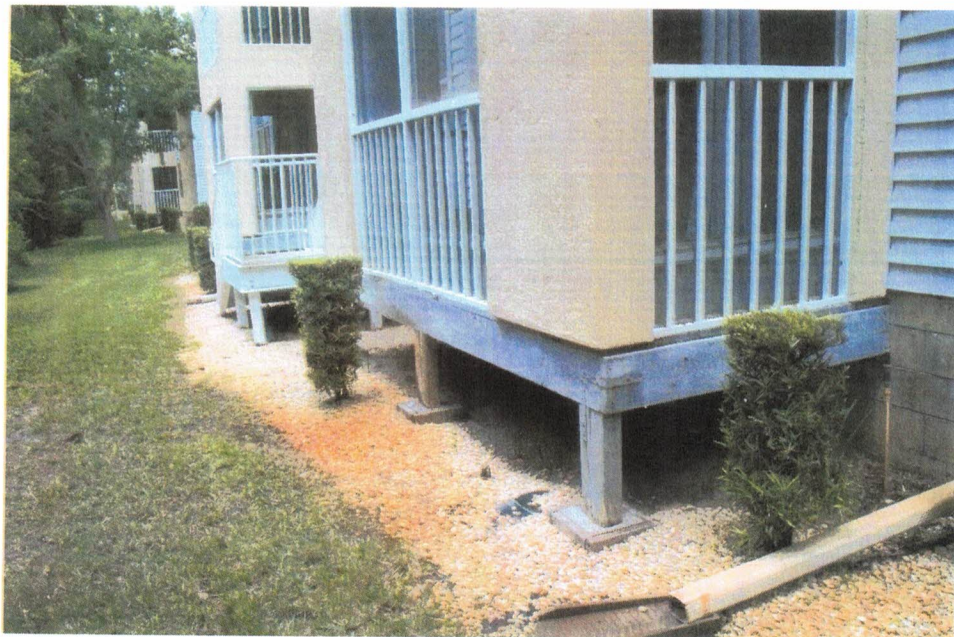
***COLUMNS SUPPORTING REAR PORCHES ON TWO BUILDINGS ARE SHOWING SIGNS OF DETERIORATION. ELITE ENGINEERING WILL PROVIDE DIRECTION TO CONDO ASSOCIATION FOR APPROPRIATE REPAIR BEFORE IT BECOMES A STRUCTURAL CONCERN.***

Elite Engineering will further coordinate with the Indigo Pines Condominium Associate to offer direction for repair of the maintenance issues observed.
